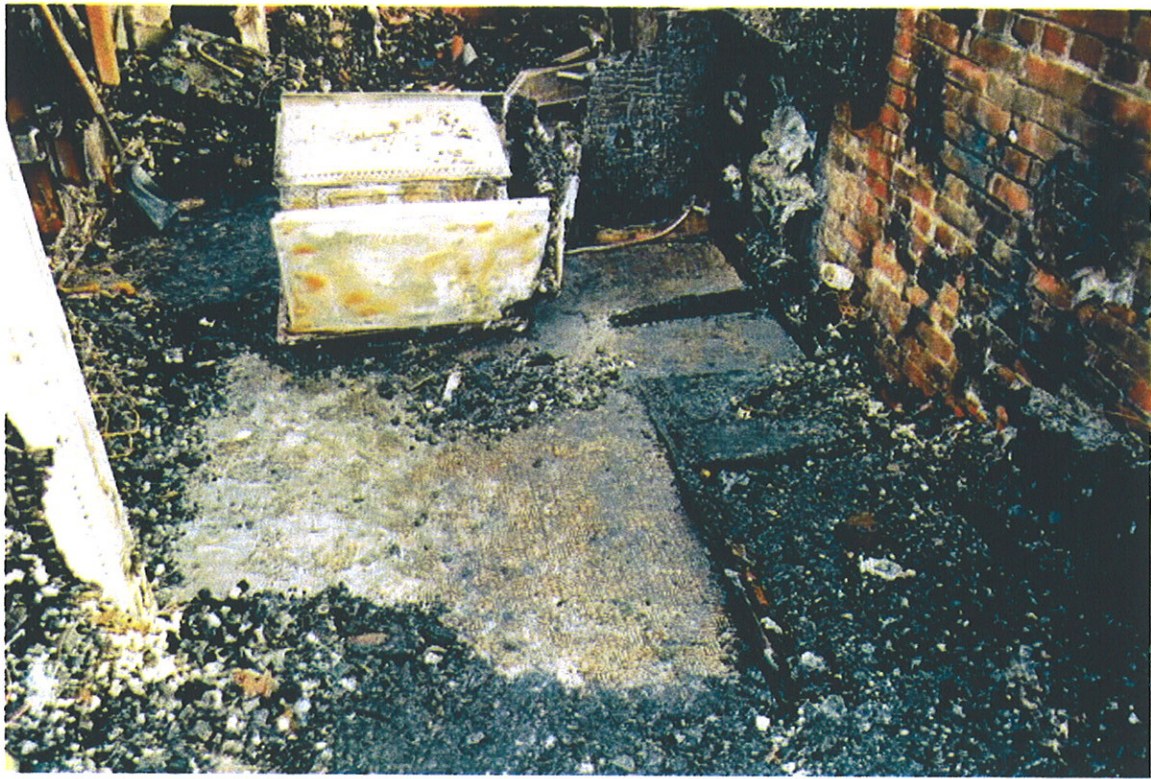
Photo 11: Excavation of area showed directional fire patterns but identified no competent heat of ignition.

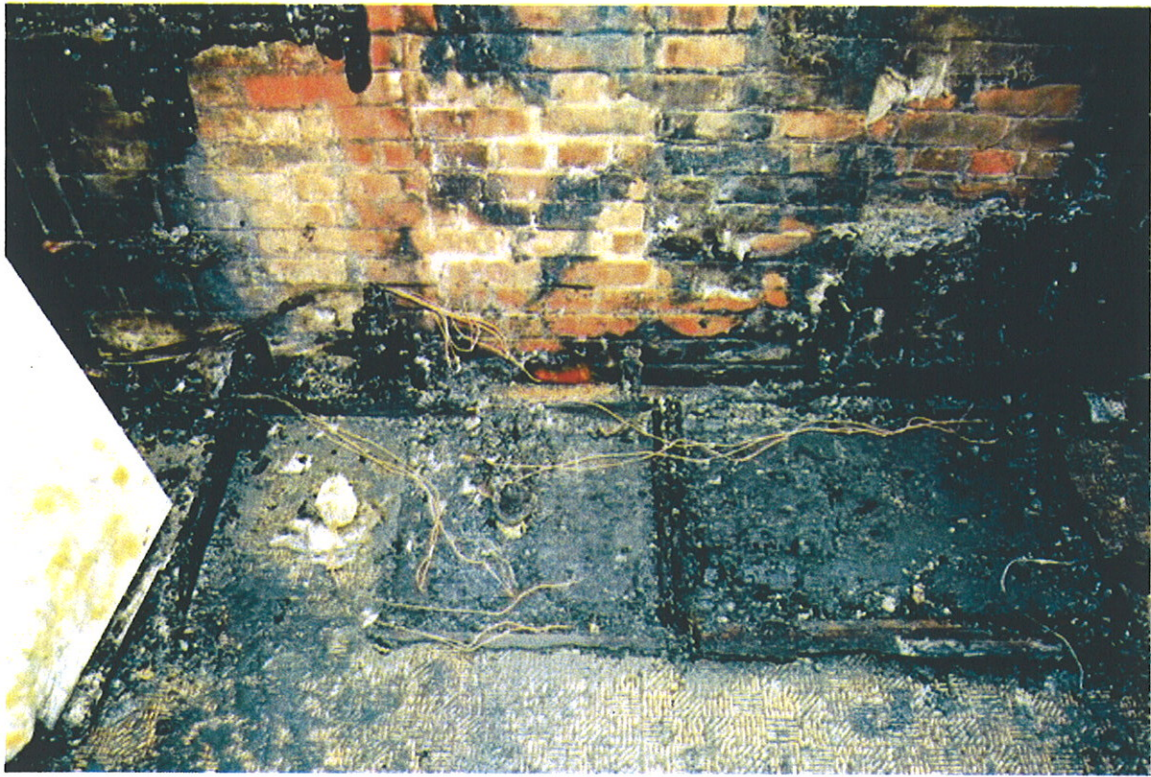
Photo 12: The first base cabinet contained a PVC drain for the sink. The remains of this PVC pipe provided additional directional fire spread patterns.

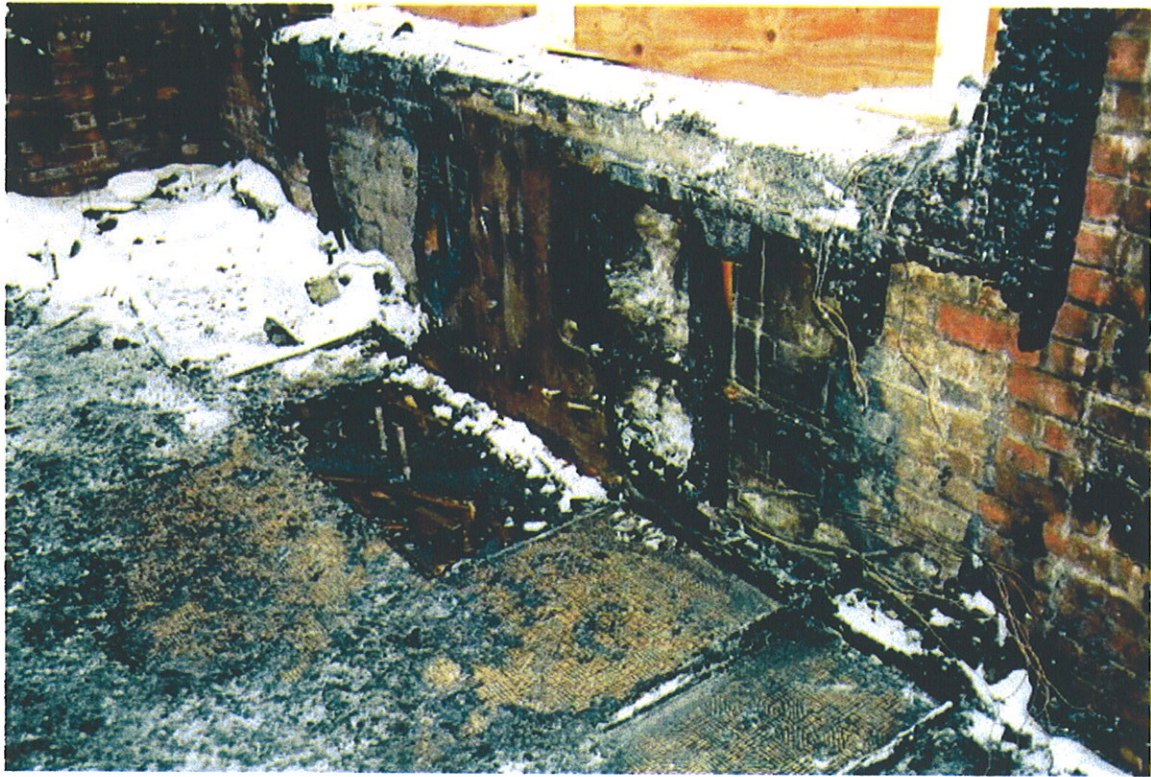
Photo 13: Openings in base cabinet (removed) and combustible wall exposed the polyethylene vapor barrier, PVC drain pipe and access to the “balloon construction-like” wood framing.

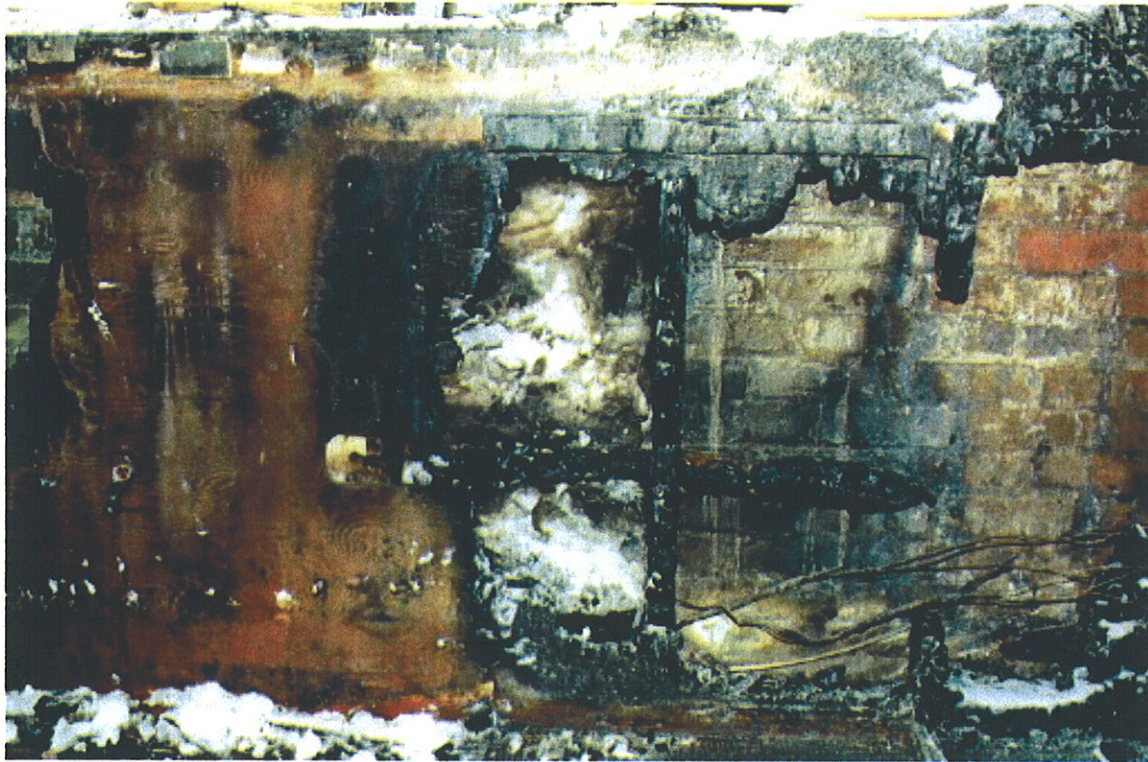
Photo 14: After the sink cabinet was removed, initial directional fire spread indicators were present on the PVC drain pipe and wood members of the wall.

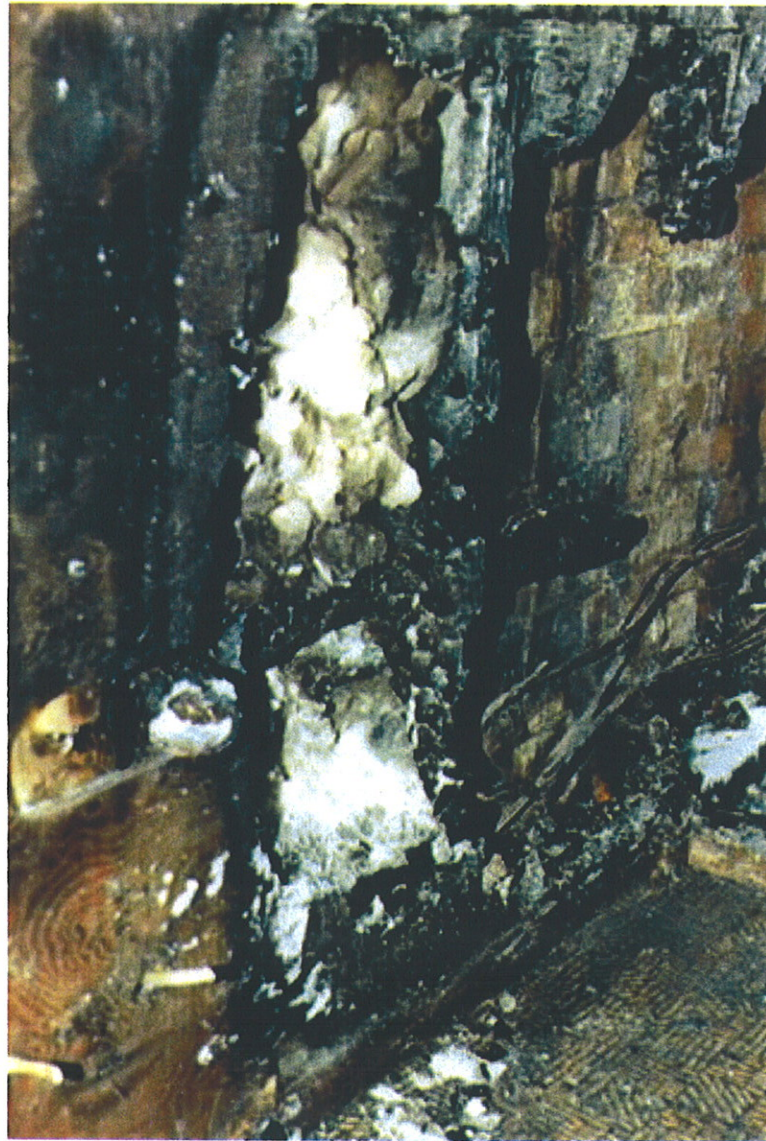
Photo 15: Another view of the indicators of initial fire spread.
